# **Navajo Abandoned Uranium Mine**

## **Site Screen Report**

### **John John 1 AUM Site**

**Navajo AUM Northern Region**

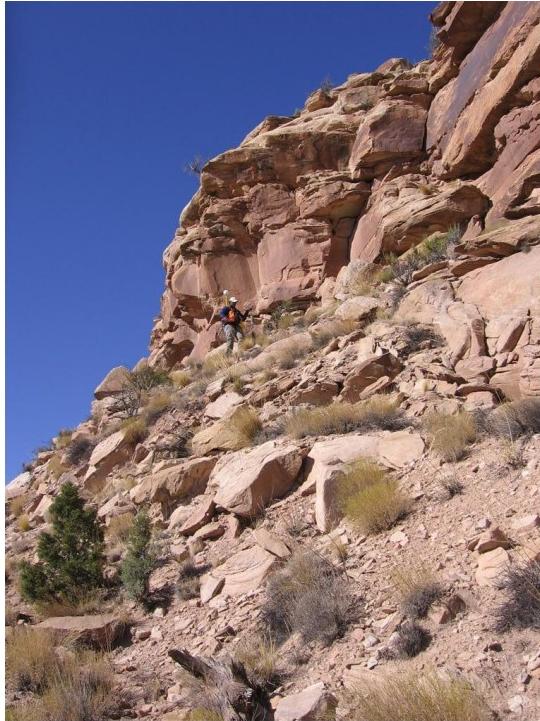
Debris in paths with elevated radiation, 100' x 50', with a total estimated volume of 926 yd<sup>3</sup>

Photo 1. Mine site #270 waste debris

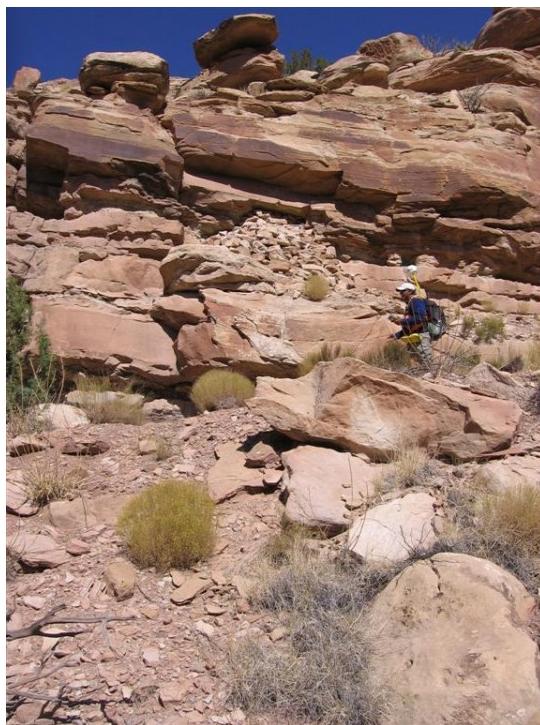
Sealed adit in cliff wall, approximately 8-ft wide by 6-ft high

Waste pile near adit, assorted smaller waste rock, 75' x 75', with a total estimated volume of 1,042 yd<sup>3</sup>

Photo 2. Mine site #271 sealed adit and waste debris

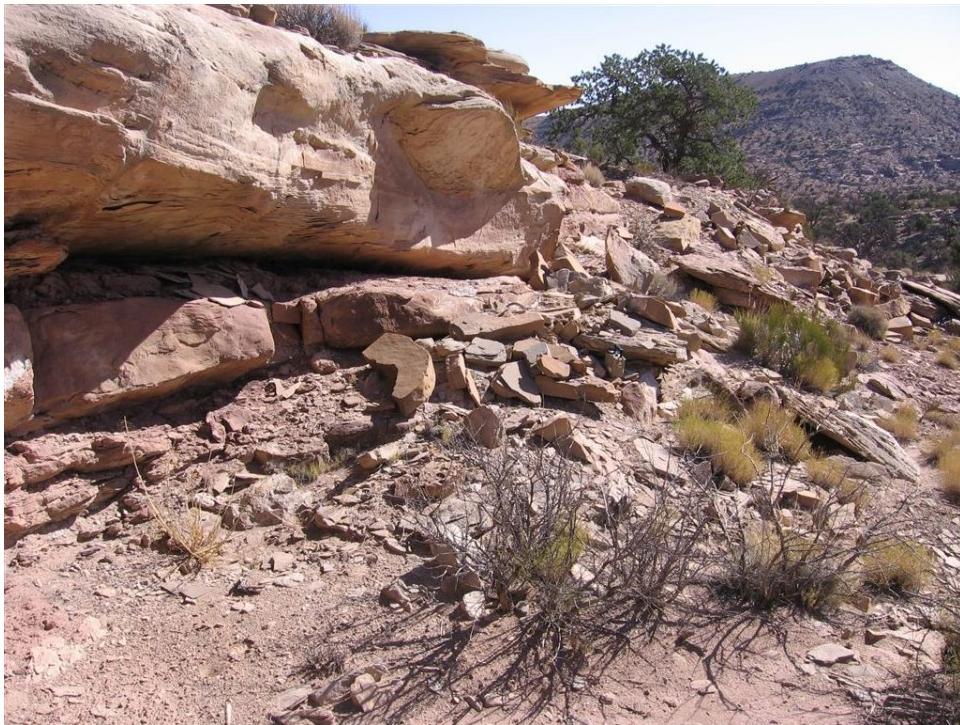
Waste piles wash down into drainage, typically small, 15' x 15' (x5), with a total estimated volume of 208 yd<sup>3</sup>

Photo 6. Photo 4. Mine site #442 waste debris
